FLOOD PLAIN INFORMATION

LAMOILLE RIVER
COLCHESTER and MILTON, VERMONT

PREPARED FOR THE TOWNS OF COLCHESTER AND MILTON AND THE VILLAGE OF MILTON
BY THE DEPT. OF THE ARMY, NEW YORK DISTRICT, CORPS OF ENGINEERS, N.Y., N.Y.

FEBRUARY 1976

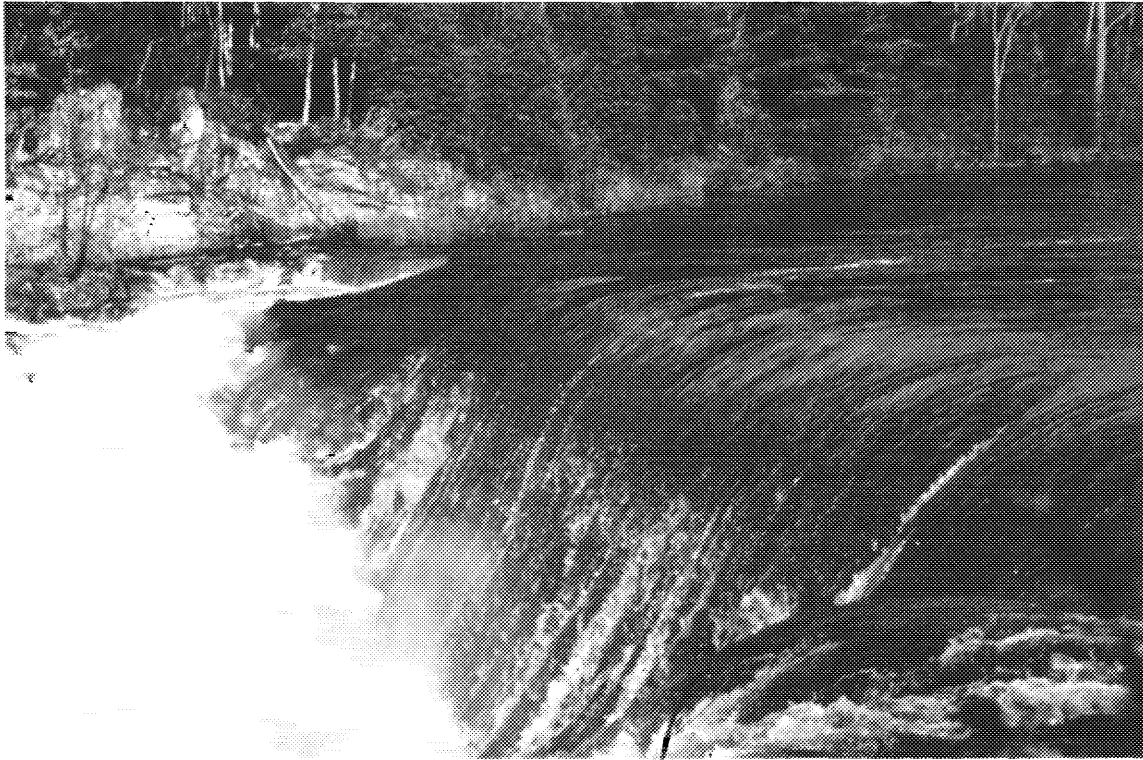
FIGURE 4 - Main Spillway-Milton Hydroelectric Station

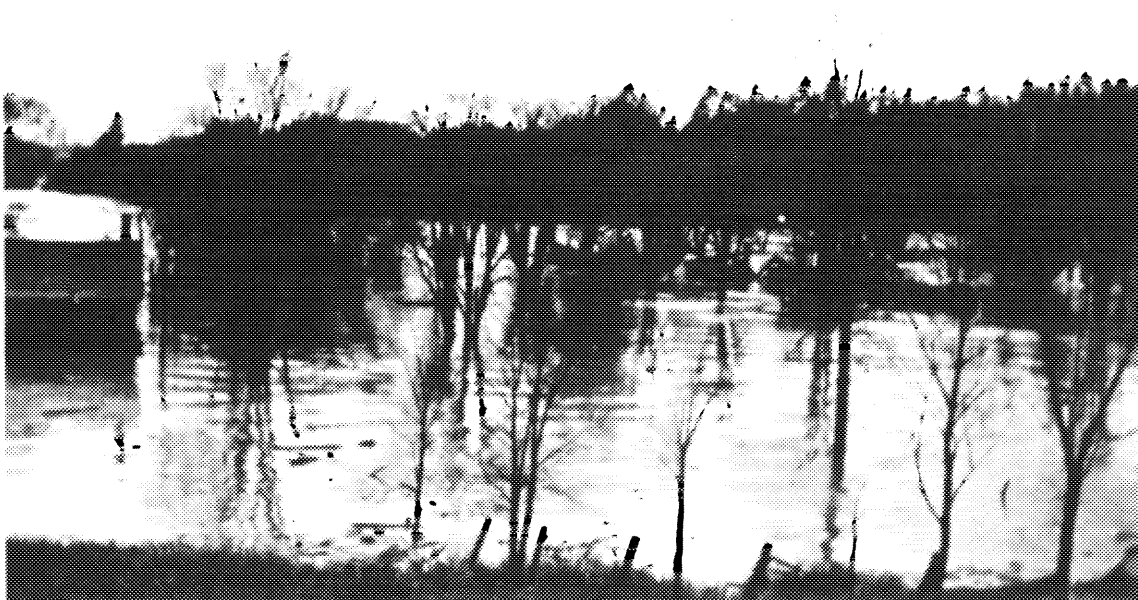
FIGURE 6 - Lamoille River flooding in Milton, Vermont during the Flood of 1927.

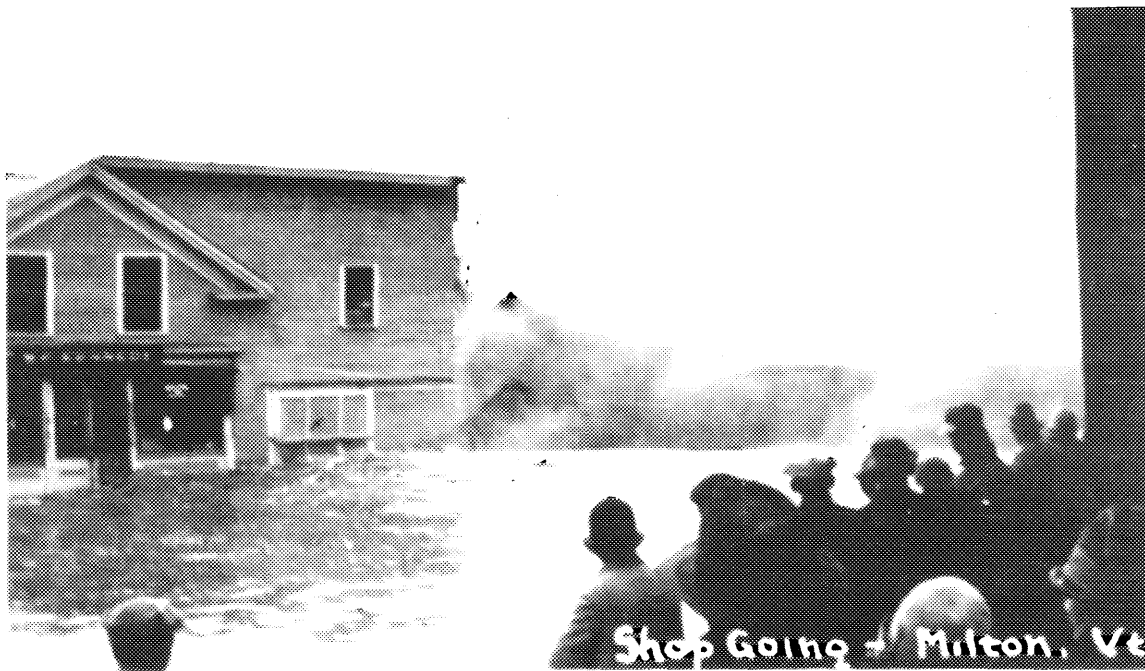
FIGURE 11 - Building being washed away by the floodwaters of the Lamoille River in 1927.

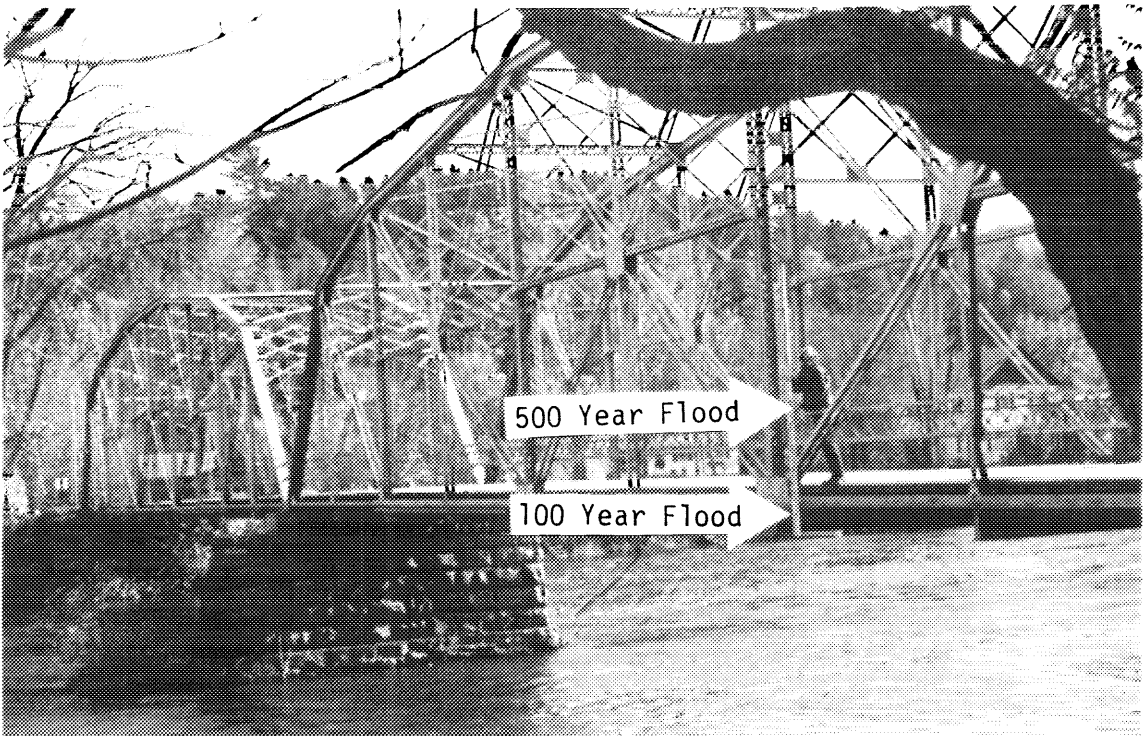
FIGURE 13 - Future flood heights at the West Milton Bridge.

Photographs, future flood heights--The levels that the 100 Year and 500 Year Floods are expected to reach at various locations along this study reach of the Lamoille River are indicated on the following photographs.

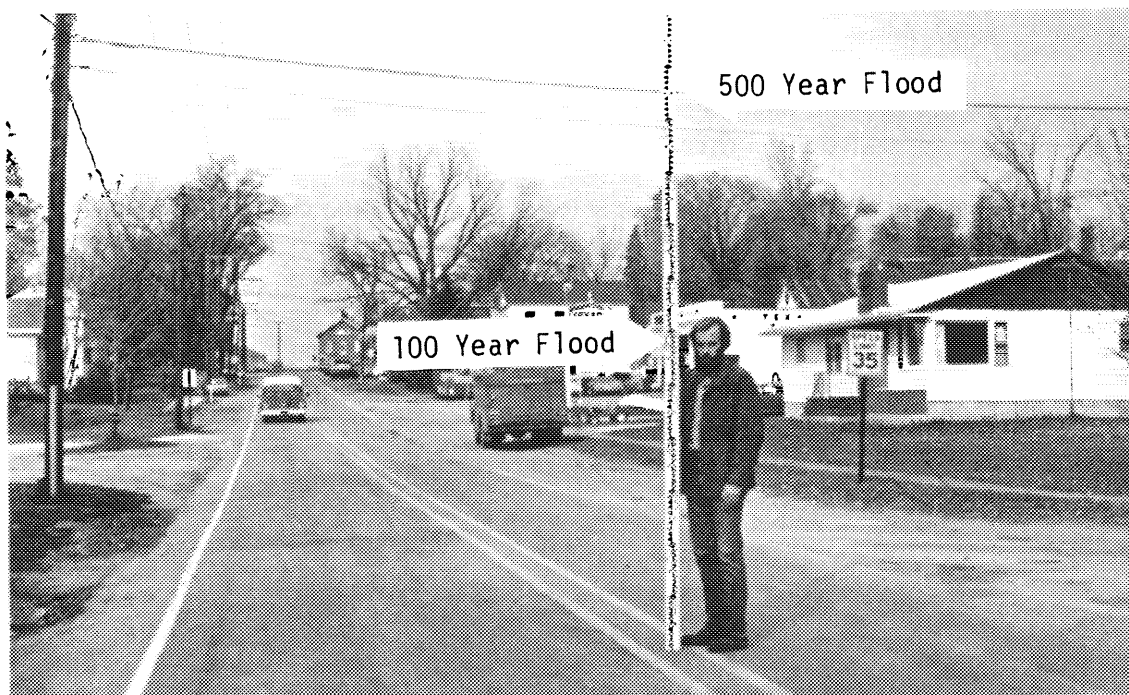
FIGURE 14 - Future flood heights along U.S. Route 7 in the Village of Milton.

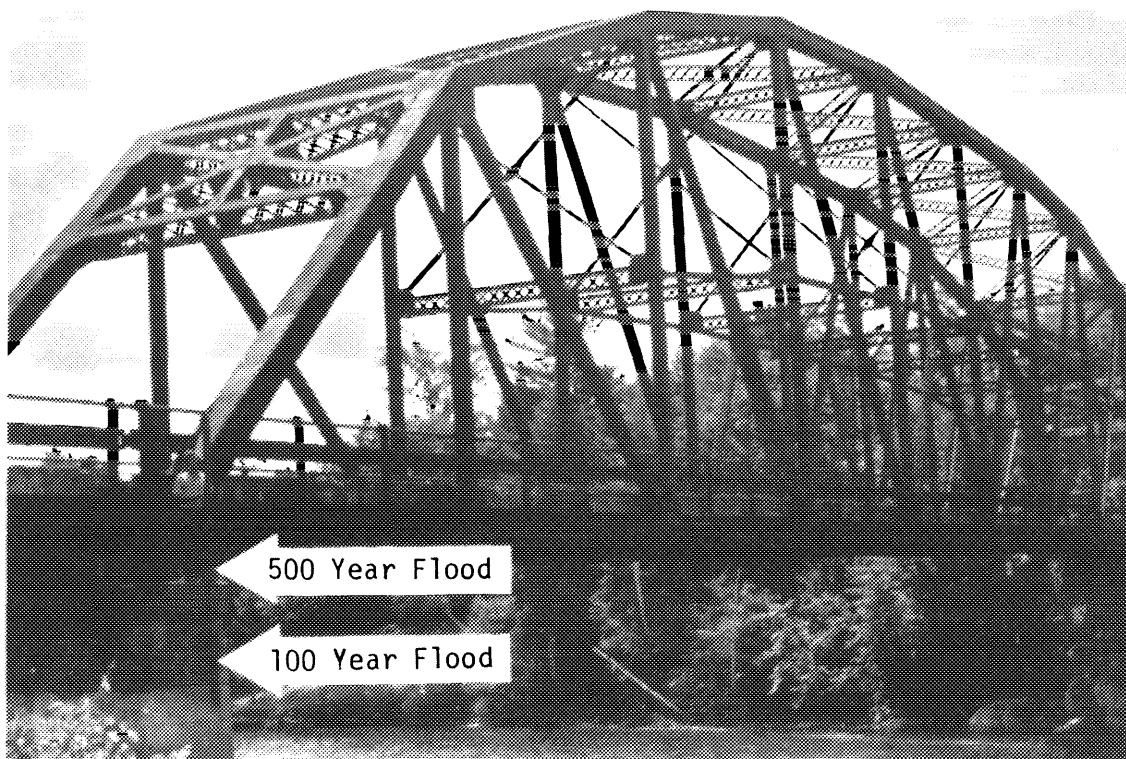
FIGURE 15 - Future flood heights at the U.S. Route 2 bridge.
